2115 24 Mile Road Sidewalk Issue with regards to sinking flags and ponding water.

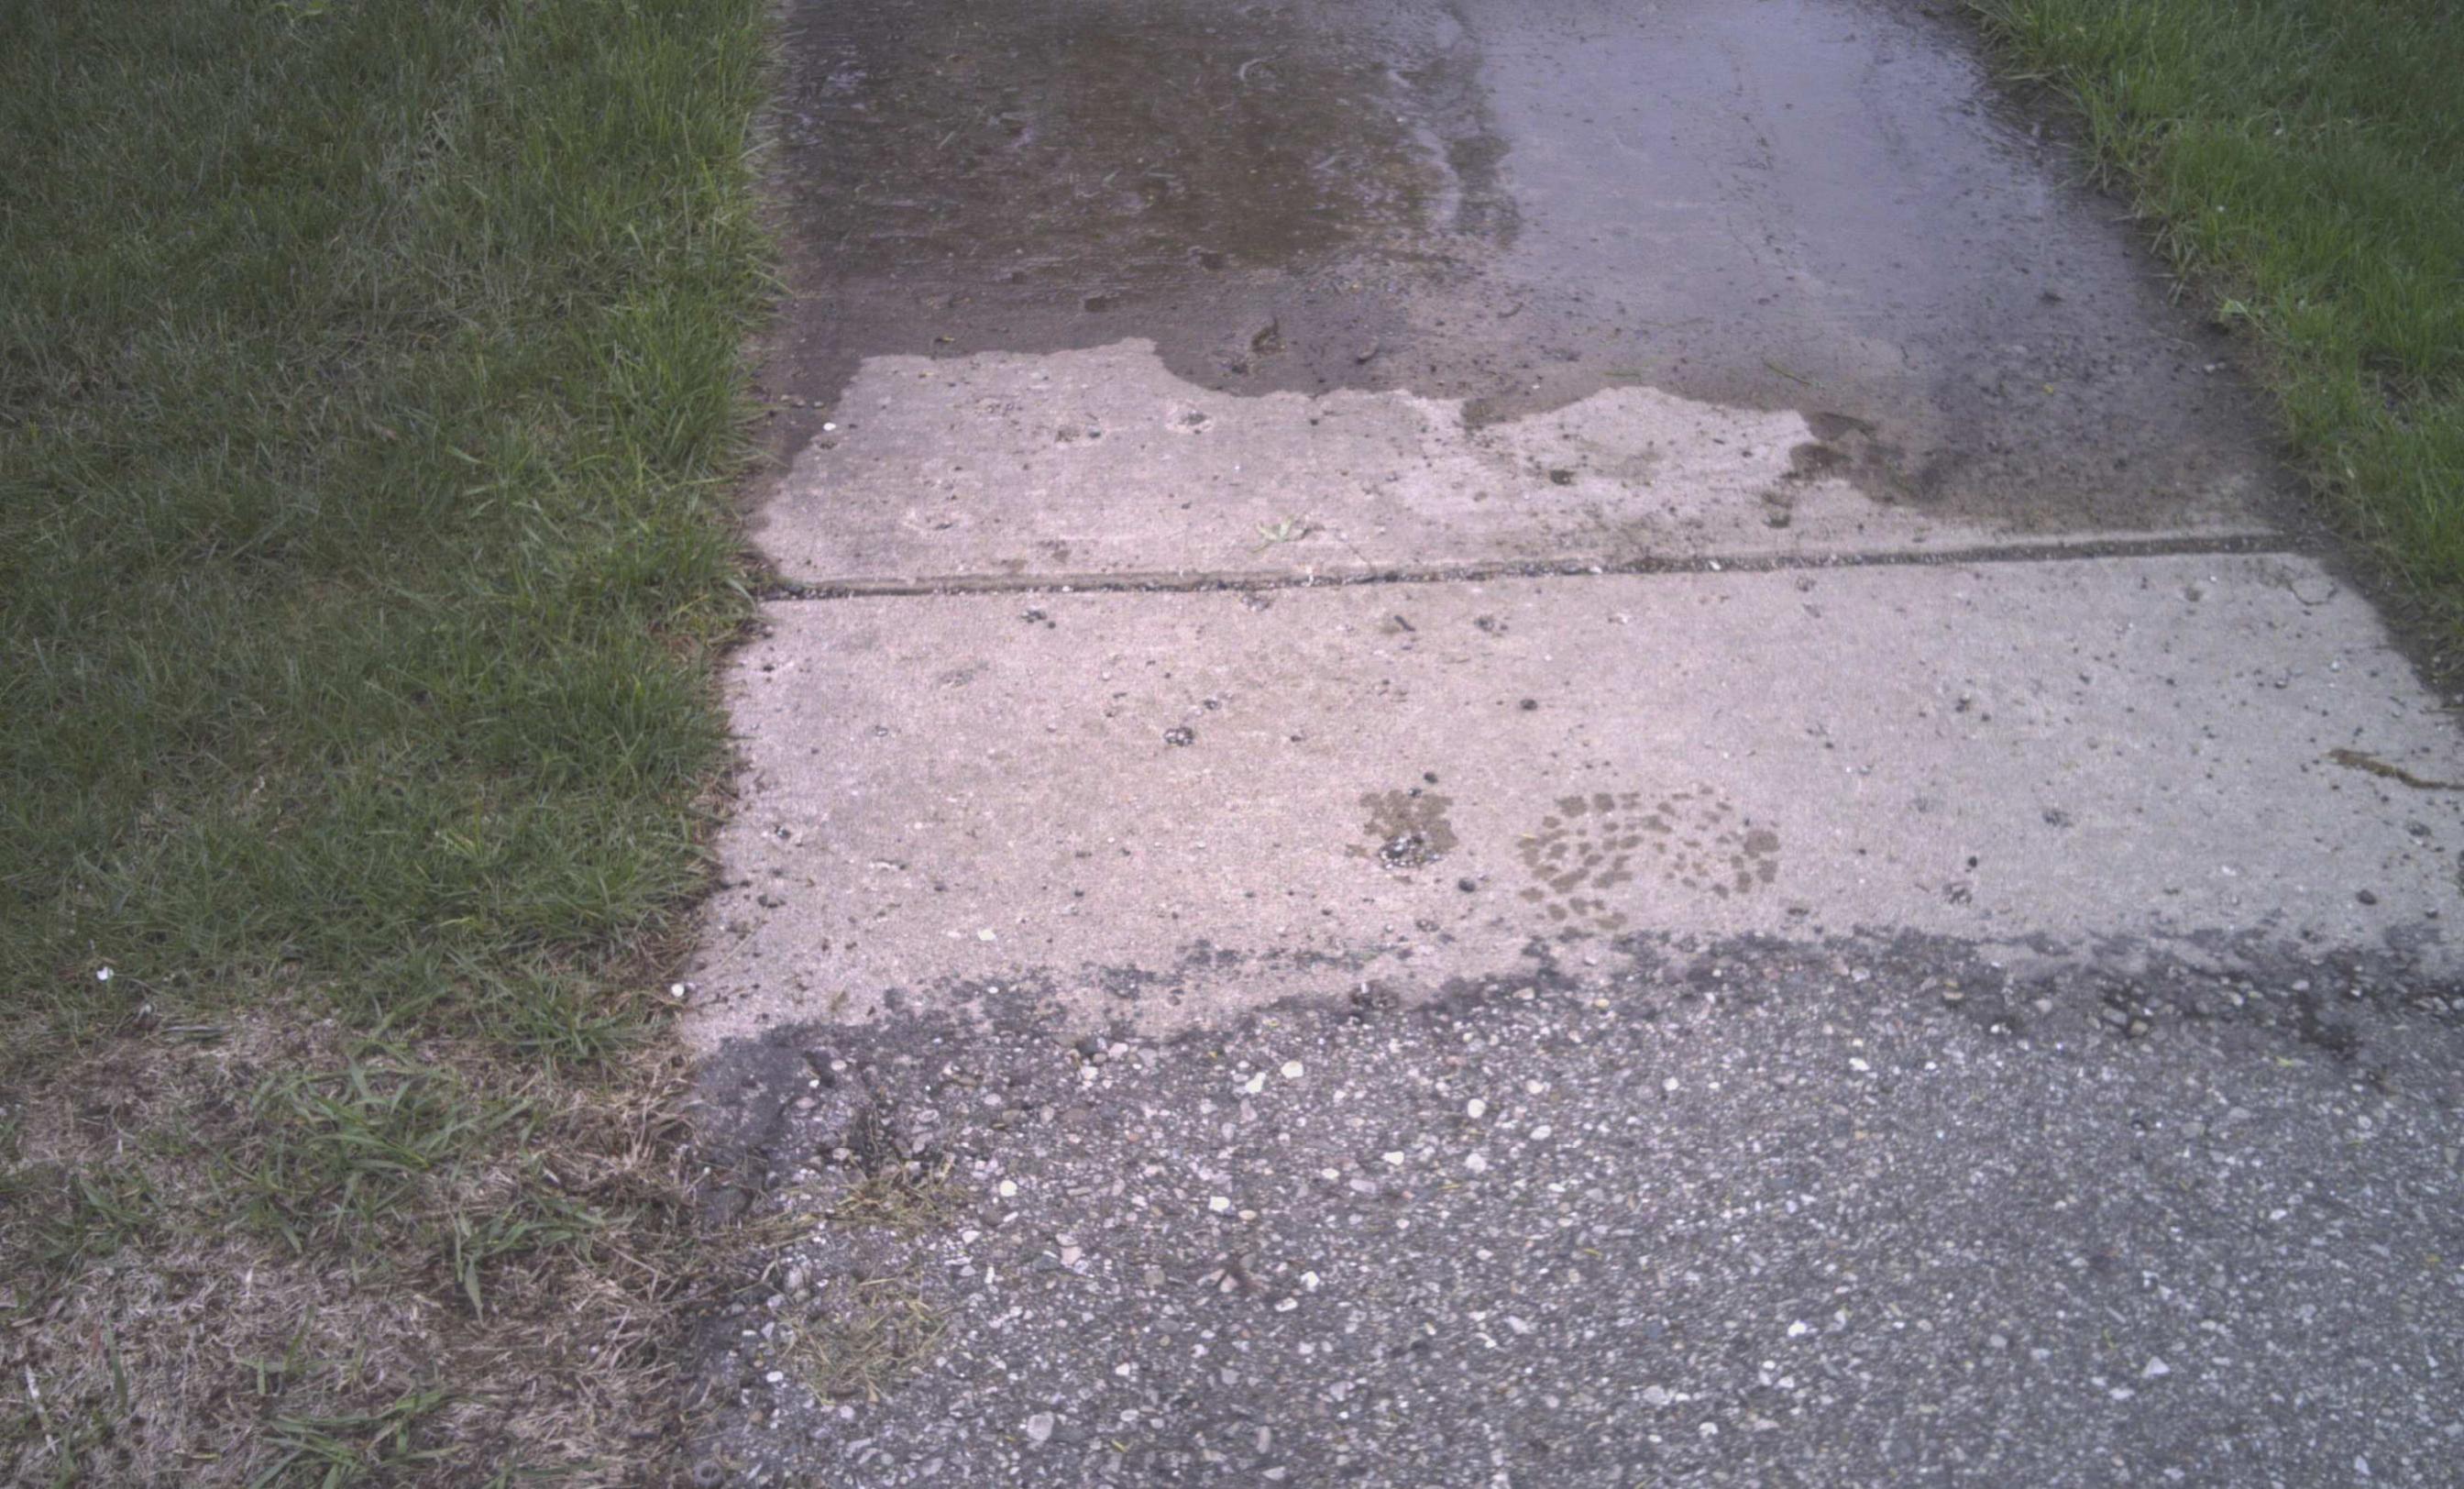
At this address, which is located in the northeast corner of 24 Mile Road and Hillsdale, there is evidence of ponding water where the sidewalk has sunk. After a site visit, it was determined the cause of the problem is the water from the north drains down the ditch on the east side of Hillsdale. The water has nowhere to go once it reaches the sidewalk. Once the water is high enough, it then proceeds across the sidewalk and enters the ditch that runs along 24 Mile Road. Looking at the corner lot on the west side of Hillsdale, which has the same layout, there is a culvert that runs under the sidewalk and empties into the ditch on 24 Mile Road. We propose that an 8 inch culvert be installed under the sidewalk to give the water, in the ditch from the north, a way to enter the 24 Mile Road ditch without flowing over the sidewalk. The sidewalk should be raised or replaced over the proposed culvert. The estimate associated with this repair would be \$700.00 for the installation of a culvert/pipe, the related grading and replacing 1 flag of sidewalk. This cost estimate doesn't include ramp work. A culvert or structure should have been installed when the sidewalk was first constructed as the case on the west side of Hillsdale. Therefore, we recommend that the township consider this replacement project as a one-time township funded project to bring it into conformance with design standards.
